Renovation Project of Boston Long Wharf Marriott

PROJECT RENOVATION OF BOSTON LONG WHARF MARRIOTT

A Major Qualifying Project
Submitted to the faculty of
Worcester Polytechnic Institute
In partial fulfillment of the requirements for the
Degree of Bachelor of Science

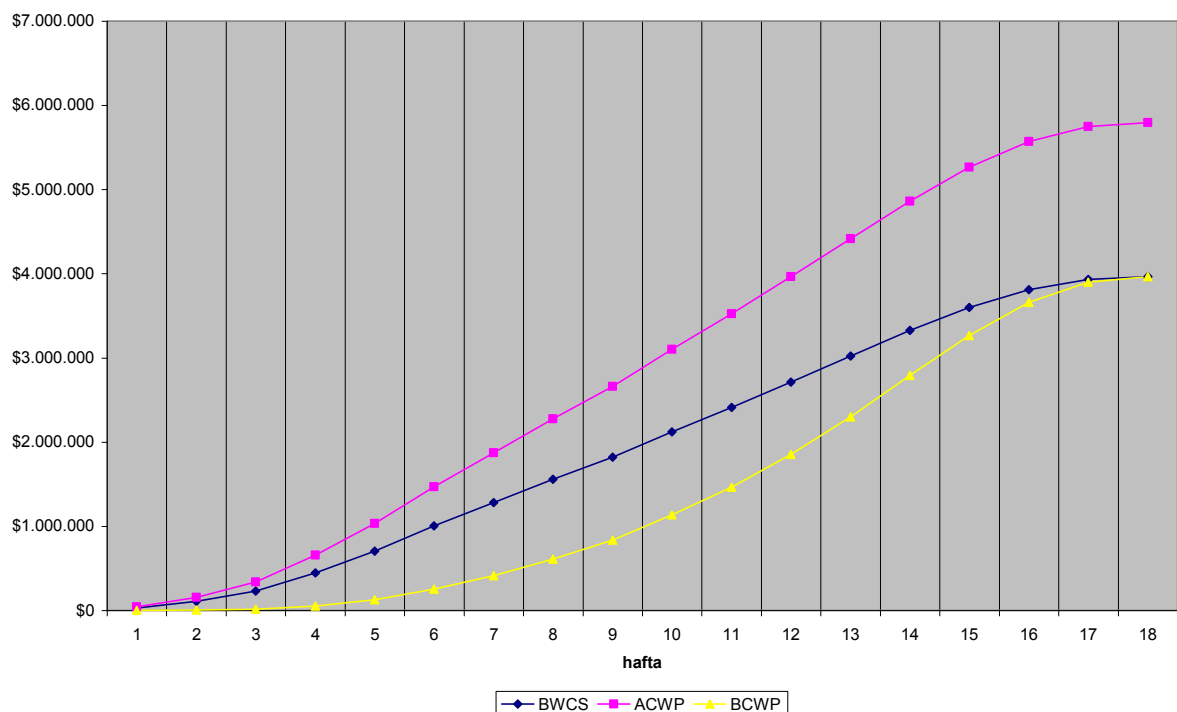
Figure 2.1: The distribution of BWCS, ACWP and BCWP

Due the fact that the project has completed, BCWS and ACWP values are compared in order to calculate cost deviations and shown in Fig. 2.1.

Budgeted cost of the programmed work for the 1st week was planned as USD 27.740 while actual cost realized as USD 40.566. The budgeted cost of the performed work is determined as USD194.

Budgeted cost of the programmed work for the 18th week was planned as USD 3.962.822 while actual cost realized as USD 5.795.139. Budgeted cost of the performed work is determined as USD 3.962.822.

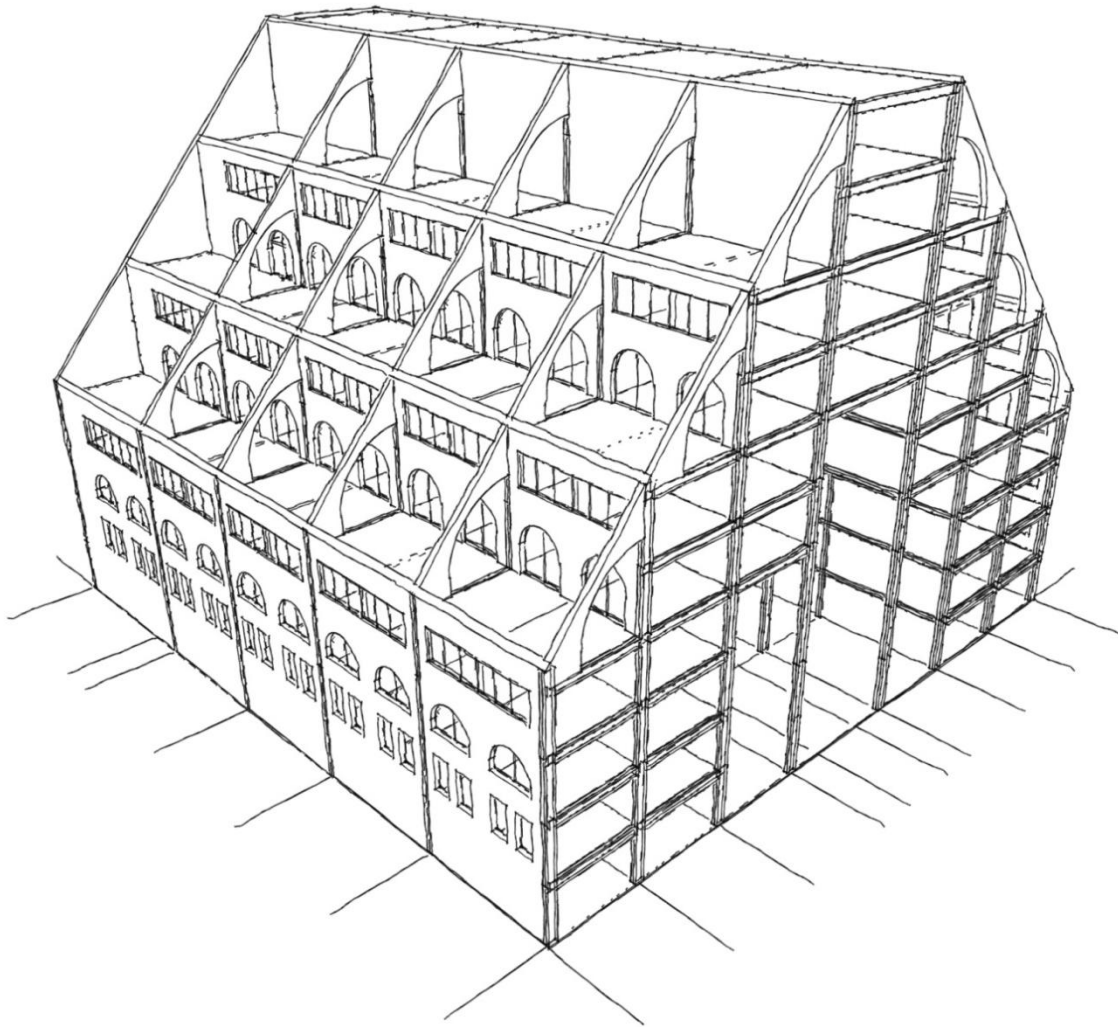
Figure 3.1 : 3D Model of Building

The 3D model of building was drawn by the program 3DMax. The perspective of the building is shown in the figure.

My 3D model represents the entire project floor by floor showing the columns, elevator pits, stairs, and interior walls. The procedure of 5D Model here was consisted of combining 3D model, ACWP values and schedules showing the phases of the model floor by floor extracted from MS Project. The renovation schedule was prepared based on floors. Calculated actual cost (ACWP) values are given by week periods. So, ACWP values for each floor renovation were determined and listed in Table 3.1. All the ACWP values shown in the table below was calculated according to the completion time of each floor.

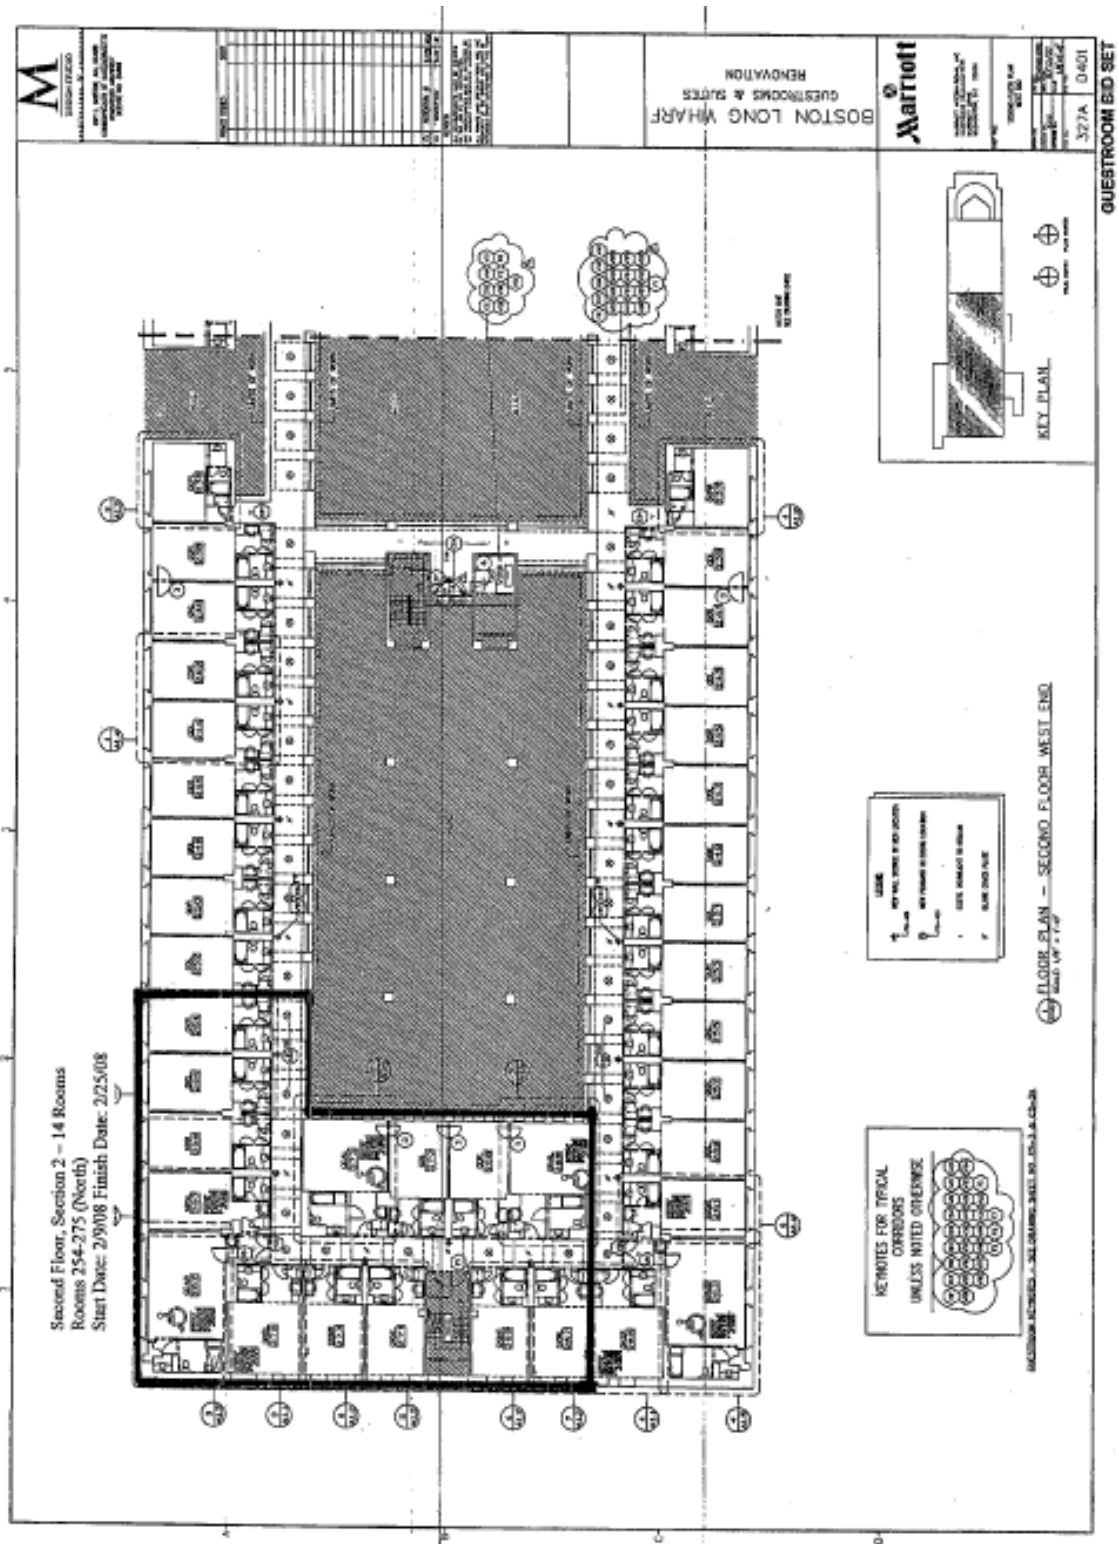
Figure 4.1: Second Floor Plan

structural plans of the existing shell structure as this building was built over 30 years ago. Architecture drawings which have no dimensional information as shown in figure 4.1(second floor plan) were taken from Turner Construction Company representatives. In order to discover the plan dimensions, hotel representatives were called and only the regular guest room dimensions was accessible . The other unknown room dimensions which are king guest room, executive suit etc were determined by measuring with AutoCAD. The regular room dimensions (19ftx12ft) are taken as a reference to find the other dimensions..

In Figure for a selected column marked on red, the capacity calculation was done. Due to lack of data in structural system, the column is redesigned in order to carry increasing live loads after the renovation. The considered loads are given below

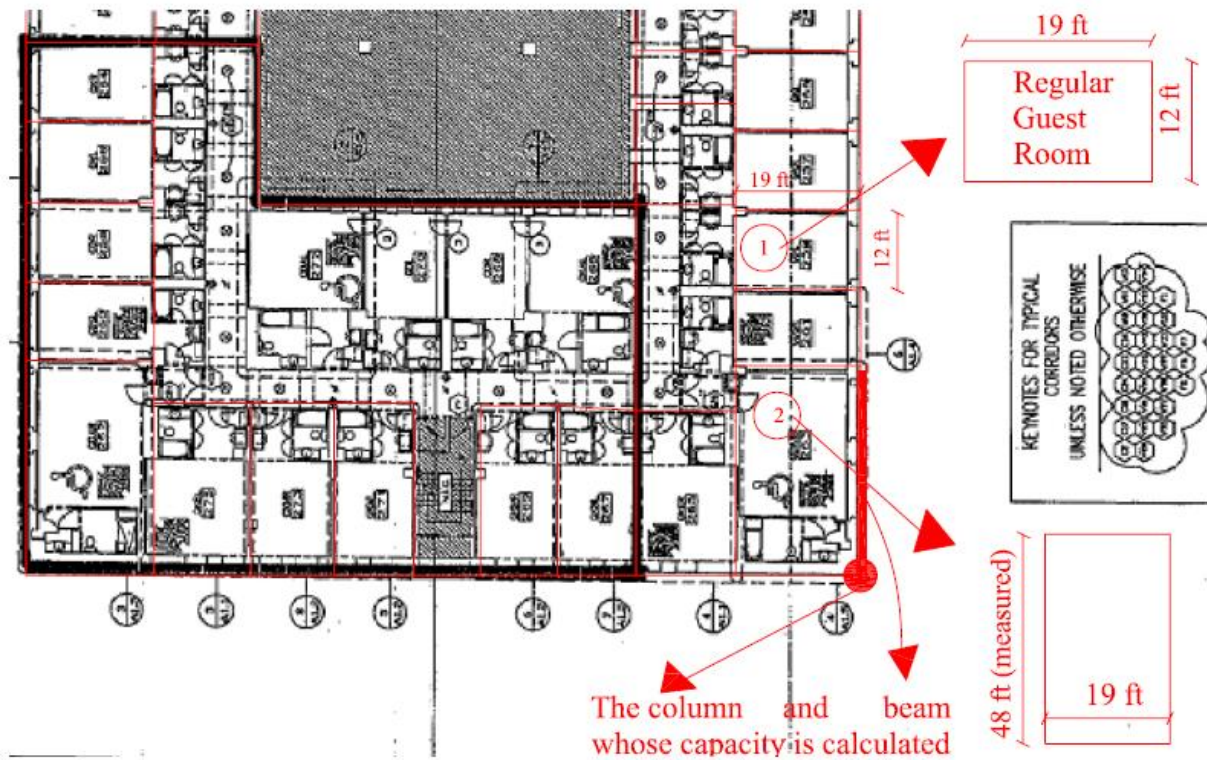
Figure 4.2: The enlarged plan of second floor

Figure 4.2 demonstrates the enlarged view of the second floor plan.

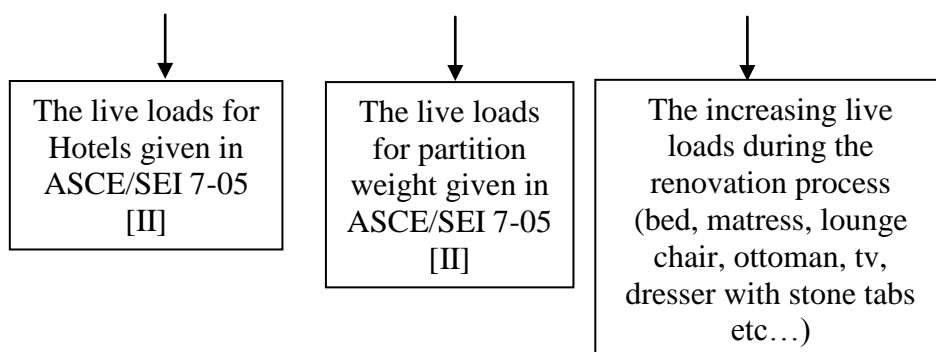
The load area for selected column is 21.17 m^2 ($2.9\text{m} \times 7.30\text{m}$). The axial force for one story is calculated as $(5.25+3) \times 21.17 = 174.7 \text{ kN}$ and the axial force for column at the base is $174.7 \times 7 = 1223 \text{ kN}$

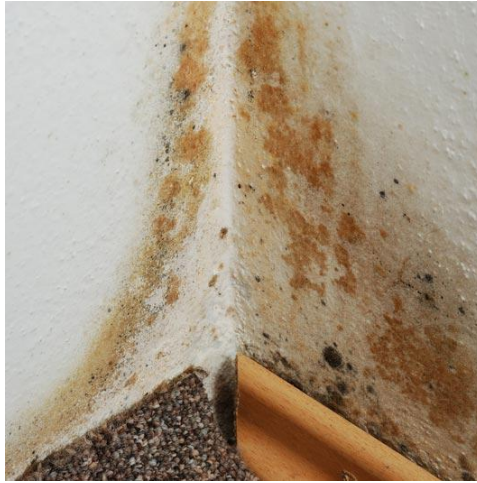
Figure 4.3: The observed mold

There was only one major challenge that the contractor faced during construction; Part of the Contractor's scope of the project was to remove the existing wall covering (wall paper) from all the rooms and corridors, once they started the project and started taking the wall coverings down, they discovered a great extent of mold damage on the walls. Dealing with mold requires special attention and procedures as it considered hazardous. The observed mold is shown in figure 4.3.

The contractor Turner proceeded with removing all mold damage off the walls by cutting the gypsum board walls and removing insulation behind it using a special mold remediation contractor. An industrial hygienist was also hired to verify that all damage was removed and all mold remediated. Due to the challenging schedule that Turner CO committed to for completion of the project and turning back rooms to the busy hotel, they were eager to rebuild the walls back to continue with the original scope of new wall covering install. There was a problem that hindered their progress however. Since the building was built in the 80's, the fire rating requirements were different to what they are now in the building code. The existing condition at the floor slab edge off the curtain wall system allowed for smoke to escape from one floor to another in case of a fire since the gap between the slab edge and the curtain wall was not sealed. The contractor Turner requested the architect and owner to address this issue at these conditions as they could not rebuild the walls to proceed with their scope without direction on this potentially costly situation. After doing some research, it was decided that the most cost effective solution would be to use dense deck to close the gap and to spray a smoke seal spray to seal it. The problem here was that they did not get this detail until two

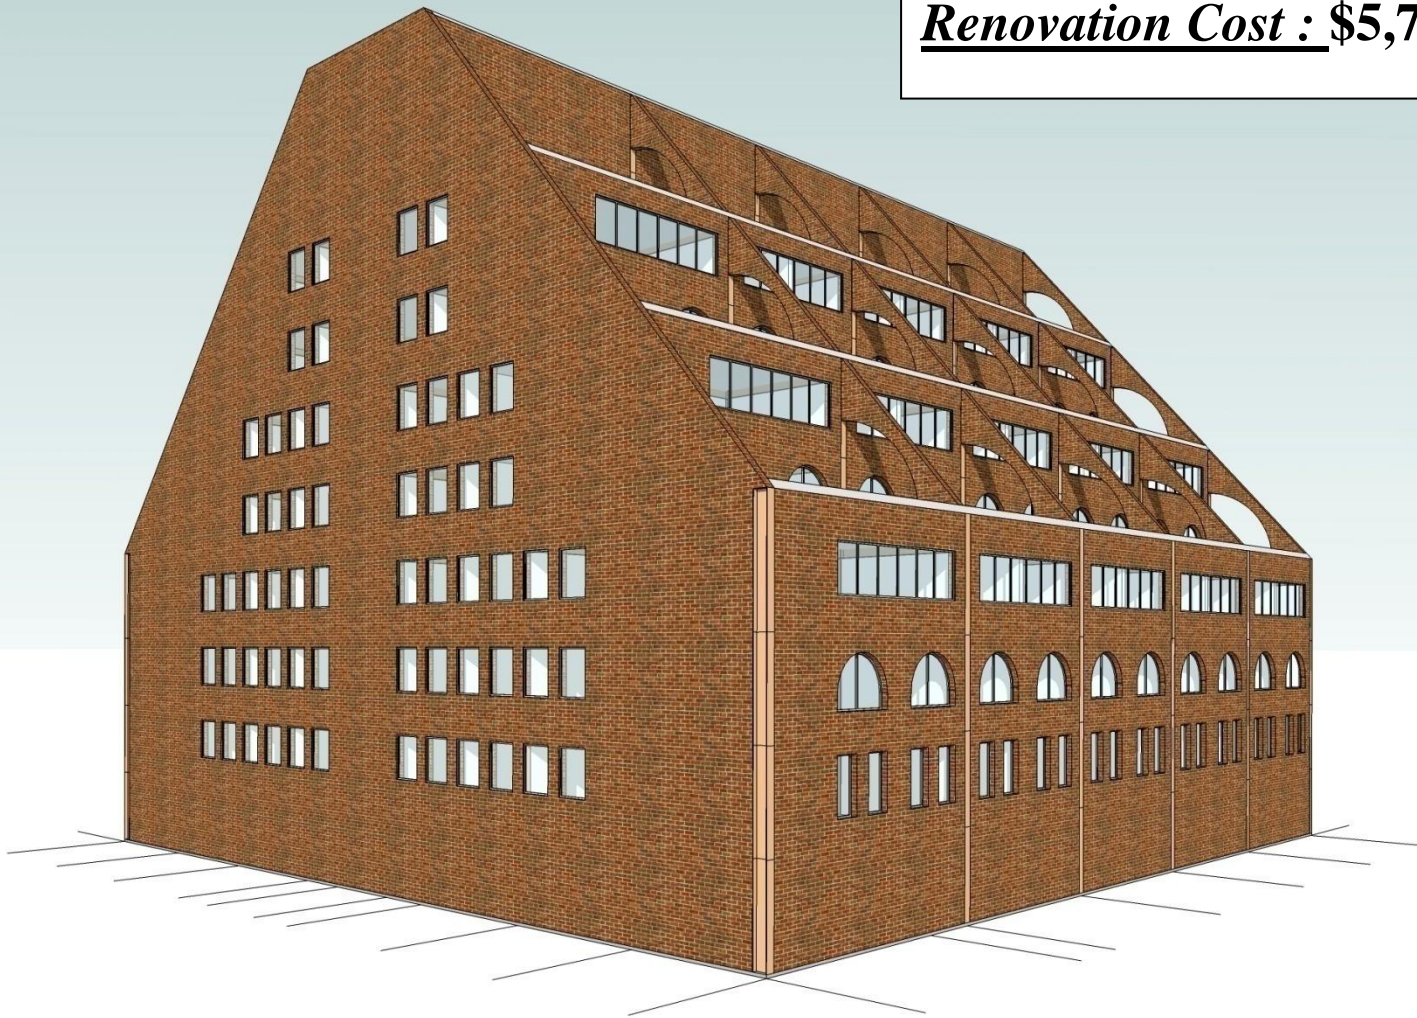
Three Dimensional Model of Building

Renovation Cost : \$5,795.139

Based on these values a 5D model was created by integrating schedule, 3D model and ACWP values. This process was done not only for entire building but also for each floor. 5D Model representation of each floor is shown in Appendix III .
